Investigation of the groundwater situation in Pesé stream area, Panama

-A Minor Field Study-

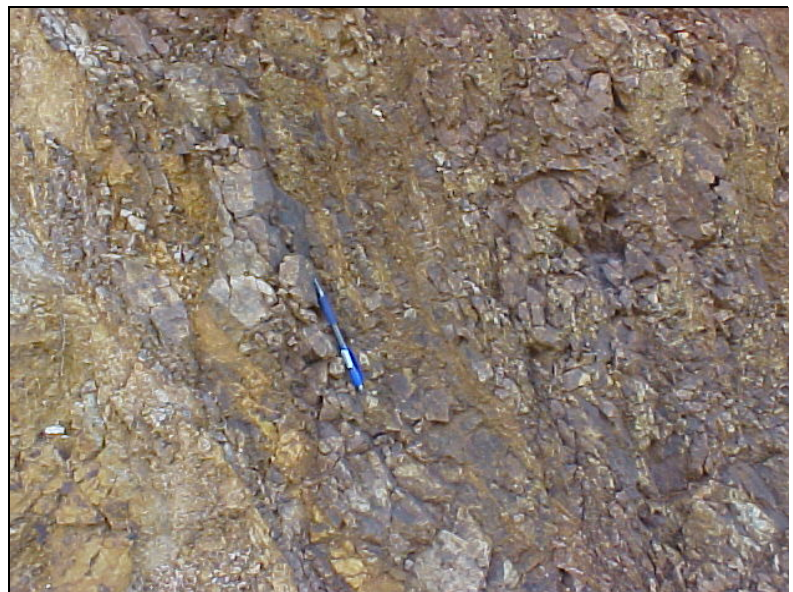
Fig 4.3.1d: Photo of weathered tuff, outcrop close to well 15 (Bulungo de La Arenita well 1 MINSA).

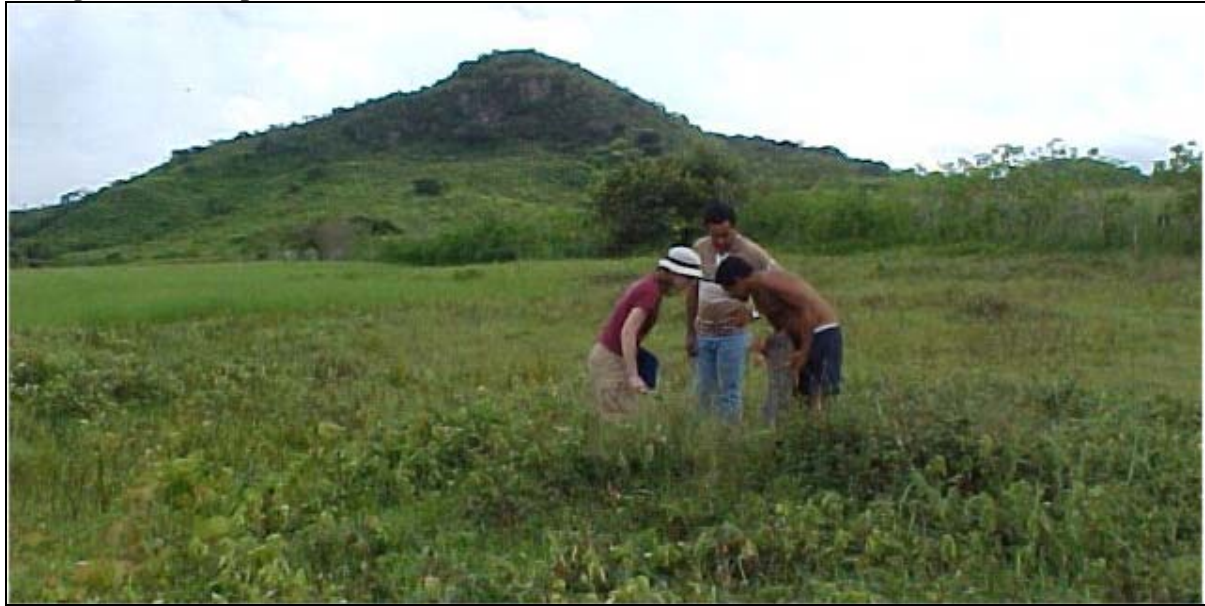
There exists almost no documentation of the wells where very little or no water at all was found. Some of these wells have been approximately located together with personal at MIDA and land owners, see figure 6.1. Oral information and the locations of these wells have then been documented in the database. There are probably several more non successful well drillings that have been missed because of lack of information and bad documentation. This affects the analyses in chapter 6.2, Well data. The conclusions of the aquifers would be more accurate if all the wells drilled in the area had been documented.

Fig 6.1: Photo of location of well 42. Malin Svendenius; Manuel Ruiz, MIDA; and Miguel Coba, landowner.

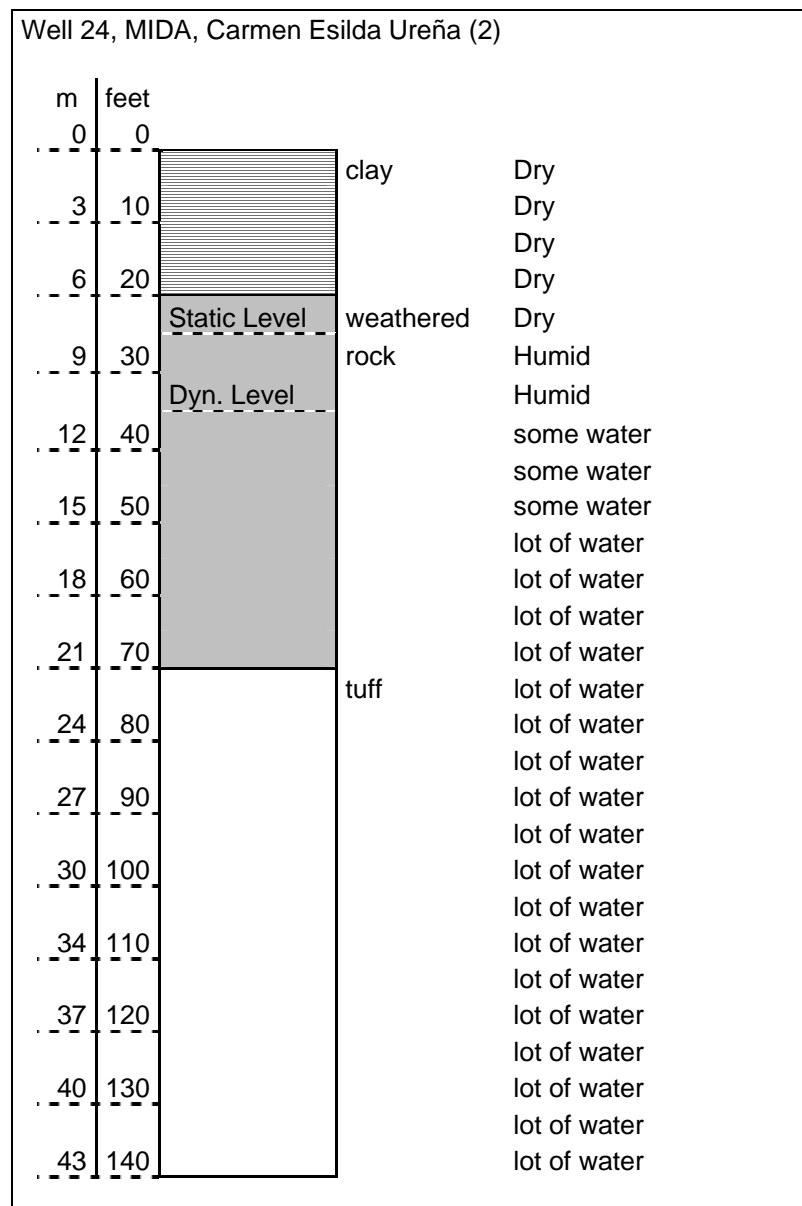
In Sabana Grande there is one well with a very good discharge, well nr 24, see figure 6.2.3b, where some water has been found in the weathered rock and a lot of water further down in the weathered rock and in the fresh rock, which is tuff. The static level is placed

in the weathered rock layer which indicates that the aquifer is unconfined, see chapter 4.4.3, and it has a good recovery capacity since the dynamic level is close to the static level.

Fig. 6.2.3b: Illustration of the geological profile of well 24 in Sabana Grande.

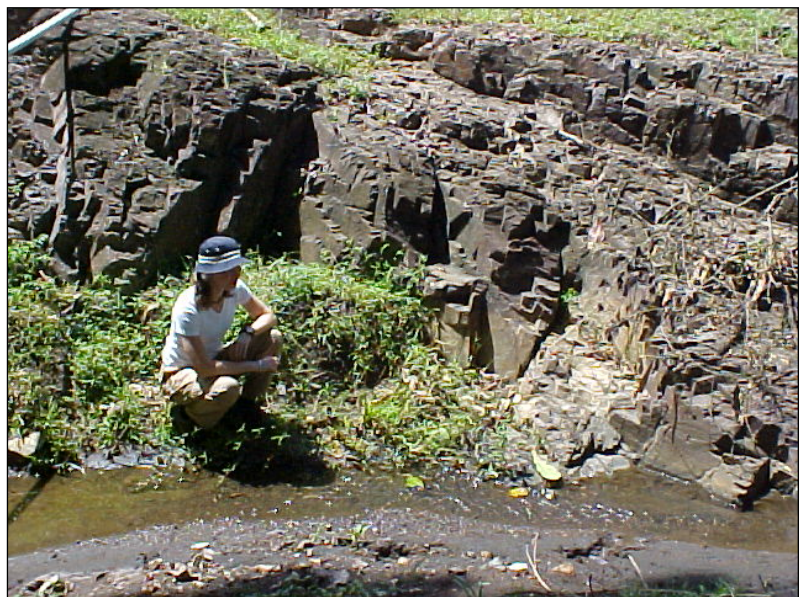
There are no geological profiles to the wells 15 and 16 in Bulungo de La Arenita but outcrops in the vicinity of the wells were studied while visiting the area. The geology in the wells is probably the same as the outcrops show. The outcrop close to well 15 shows weathered tuff, see figure 4.3.1d and this well has a good discharge. The outcrop close to well 16 shows silicified volcanic rock, see figure 6.2.3e. This well has a low discharge.

Fig. 6.2.3e: Photo of outcrop of silicified volcanic rock close to well 16 in Bulungo de La Arenita.

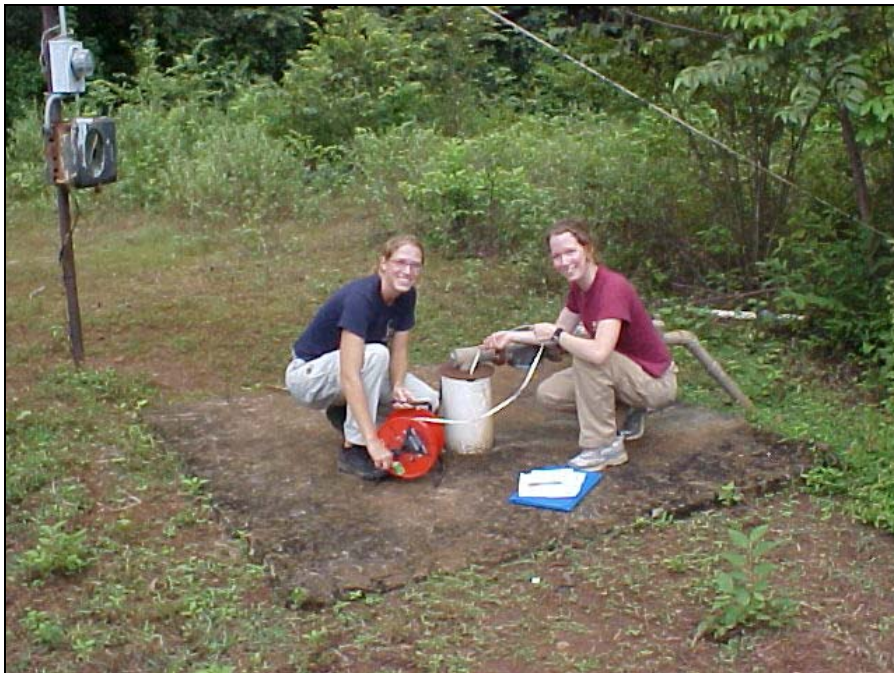
Fig 6.2.4a: Photo of measurement of the water level in well 8 (IDAAN B9) in Pesé by Lena Sjunnesson and Malin Svendenius.

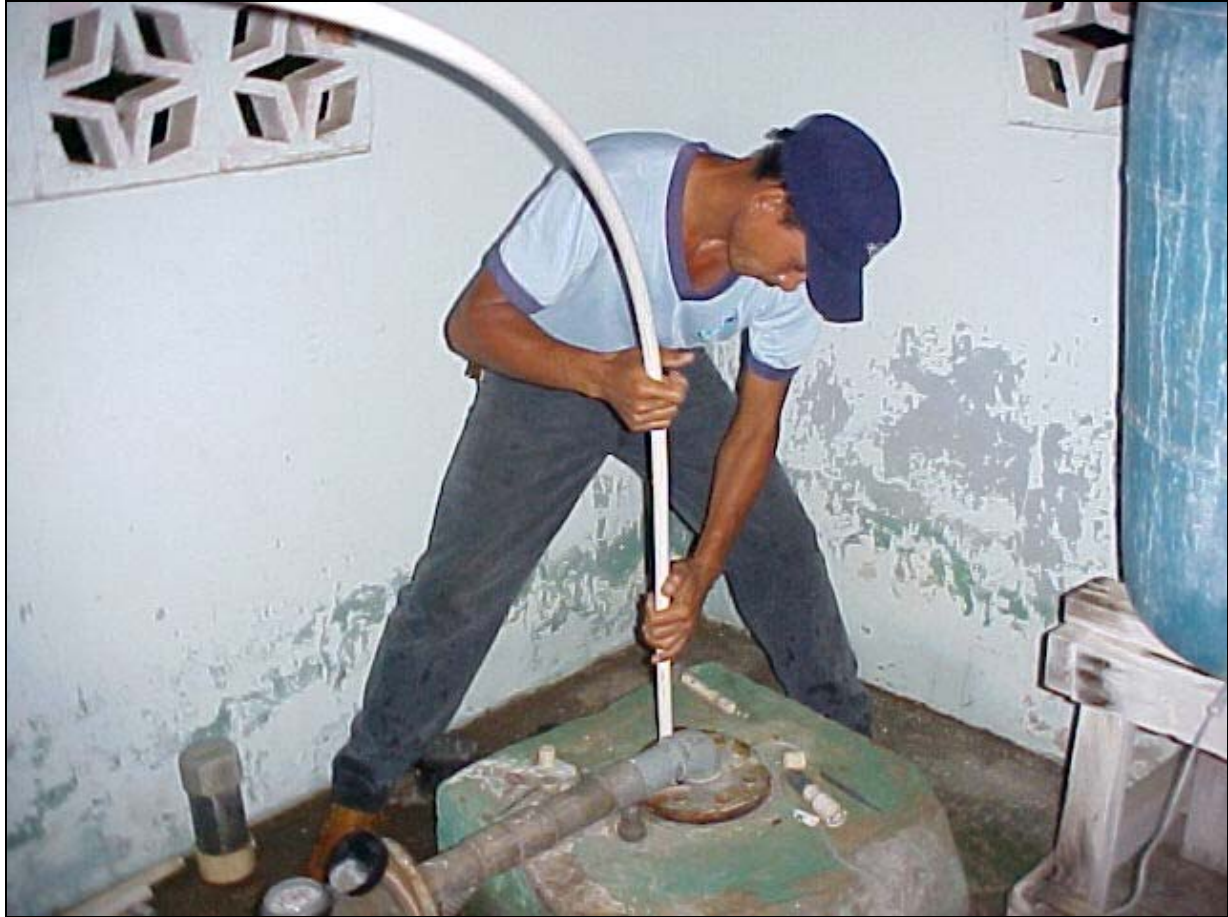
Fig. 6.2.4b: Photo of well operator Luis Valdez, IDAAN, taking out the plastic tube in well 1 (IDAAN B1) in Pesé so that measurements can be done.

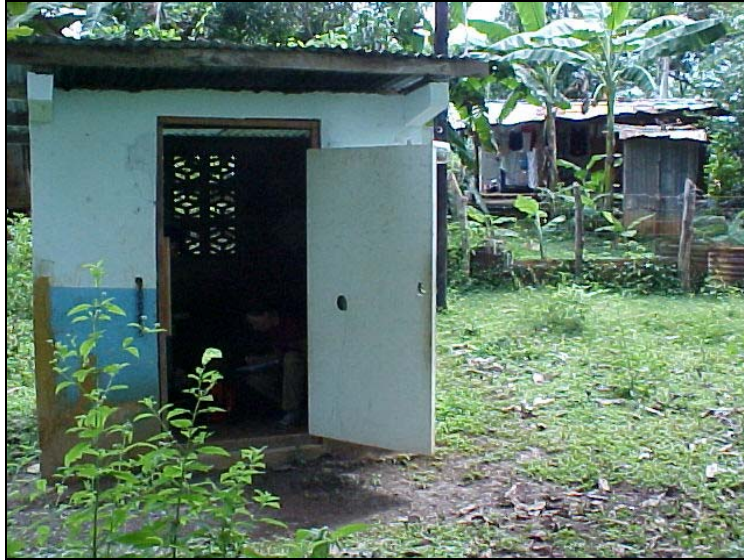
The domestic sewage is mainly from Pesé where water closets are used. This water is not treated in any way and is probably discharged directly into the Pesé stream. In the outskirts of Pesé and on the countryside outside lavatories are used which usually not affect the ground and surface water in the vicinity. However, if the outside lavatories are situated in a wrong place the contaminations can be a threat to the groundwater that is used for domestic use. This happens if the contaminations are not broken down before they reach the well. It can also be a threat to the surface water in the stream. Figure 6.7.1a shows outside lavatories close to a well house in Pesé.

Fig 6.7.1a: Photo of a well-house painted in white and blue close to an outside lavatory in the outskirts of Pesé.

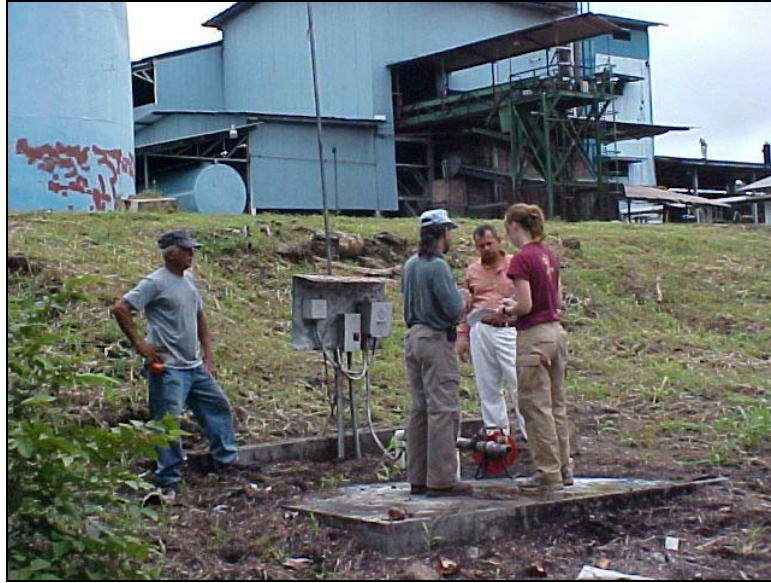
Fig. 6.7.1c: Photo of a well in front of the Varela Hermanos sugar cane mill.

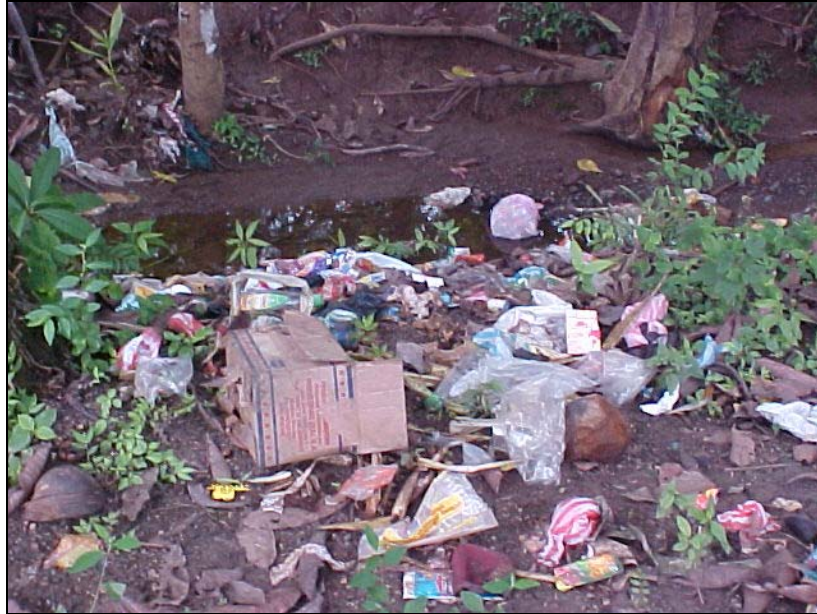
In some places garbage is not taken care of properly. It has been left by the side of the road or by the stream. It can leak unhealthy substances to the surface and groundwater. Figure 6.7.1d is taken close to well 5 (B6) in Pesé with a ditch leading to Pesé stream close by.

Fig. 6.7.1d: Photo of garbage by the stream in the outskirts of Pesé.
