Investigation of the groundwater situation in Pesé stream area, Panama

-A Minor Field Study-

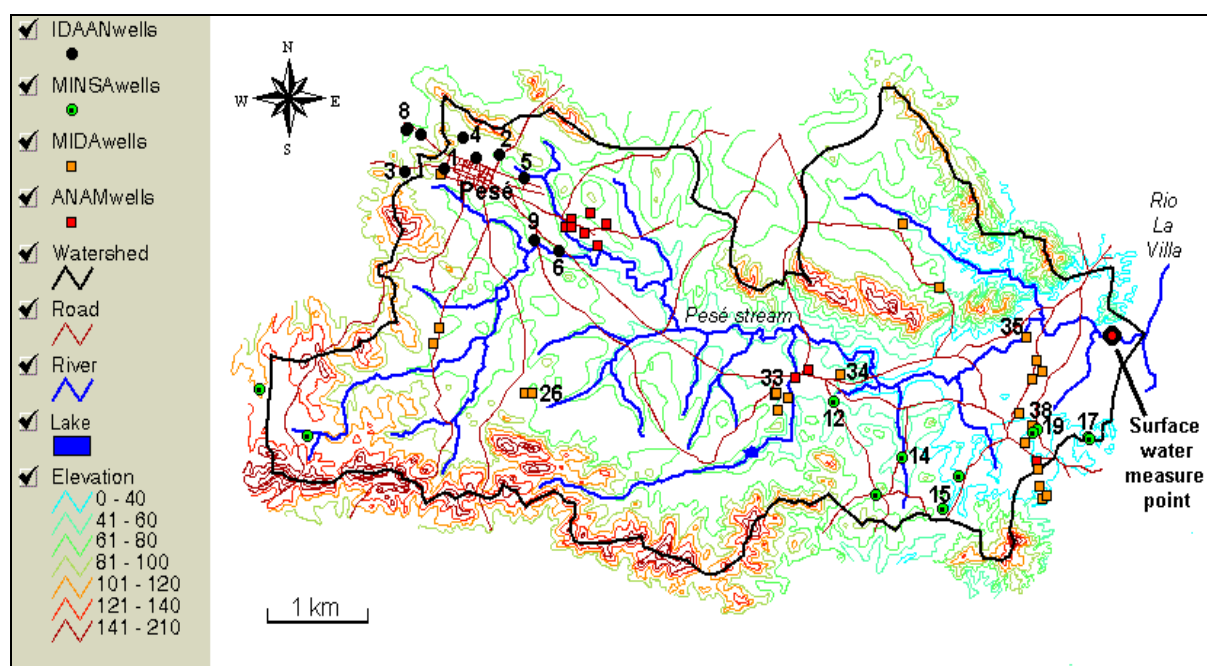
Fig 6.6.1: Map of the chemistry measure points in the study area.

Water samples were taken and analysed in 12 places in the watershed once during the dry season and once during the rain season by ANAM. One of these places is situated in the project area. Water samples were taken in the Pesé stream, in the area of Las Cabras, see figure 6.6.1. The different water chemistry analyses can be seen in table 6.6.1a together with the results from the Pesé stream. Below table 6.6.1a follow an explanation of the different water chemistry analyses.

The tables show that the water has a bad quality during the whole year. According to the Chilean and Brazilian norm it is only appropriate for industrial use or less demanding usages during the rain season. During the dry season it is appropriate for drinking water for animals and restricted irrigation as well. It can also be used for drinking water for humans if it is treated the right way according to the European Union norm.

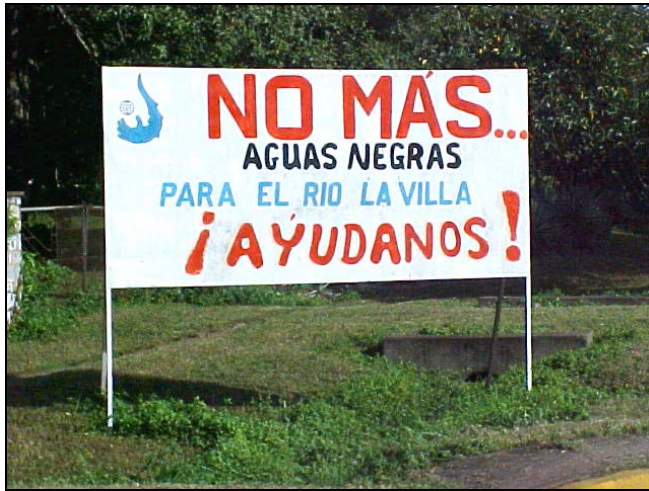
Fig. 6.7.1b: Photo of a poster with the text: 'No more sewage water to Rio La Villa, help us!'

There is an organisation created for the purpose to stop the discharge of domestic sewage to the river Rio La Villa. If the organisation raises enough money they will build a treatment plant in Los Santos, to start with. This will not affect Pesé watershed directly, since Los Santos is much further downstream river Rio La Villa , but the knowledge that is spread will probably effect future work. A conspicuous poster by the main road in Los Santos with the text: 'No more sewage water to Rio La Villa, help us!' is shown as figure 6.7.1b.

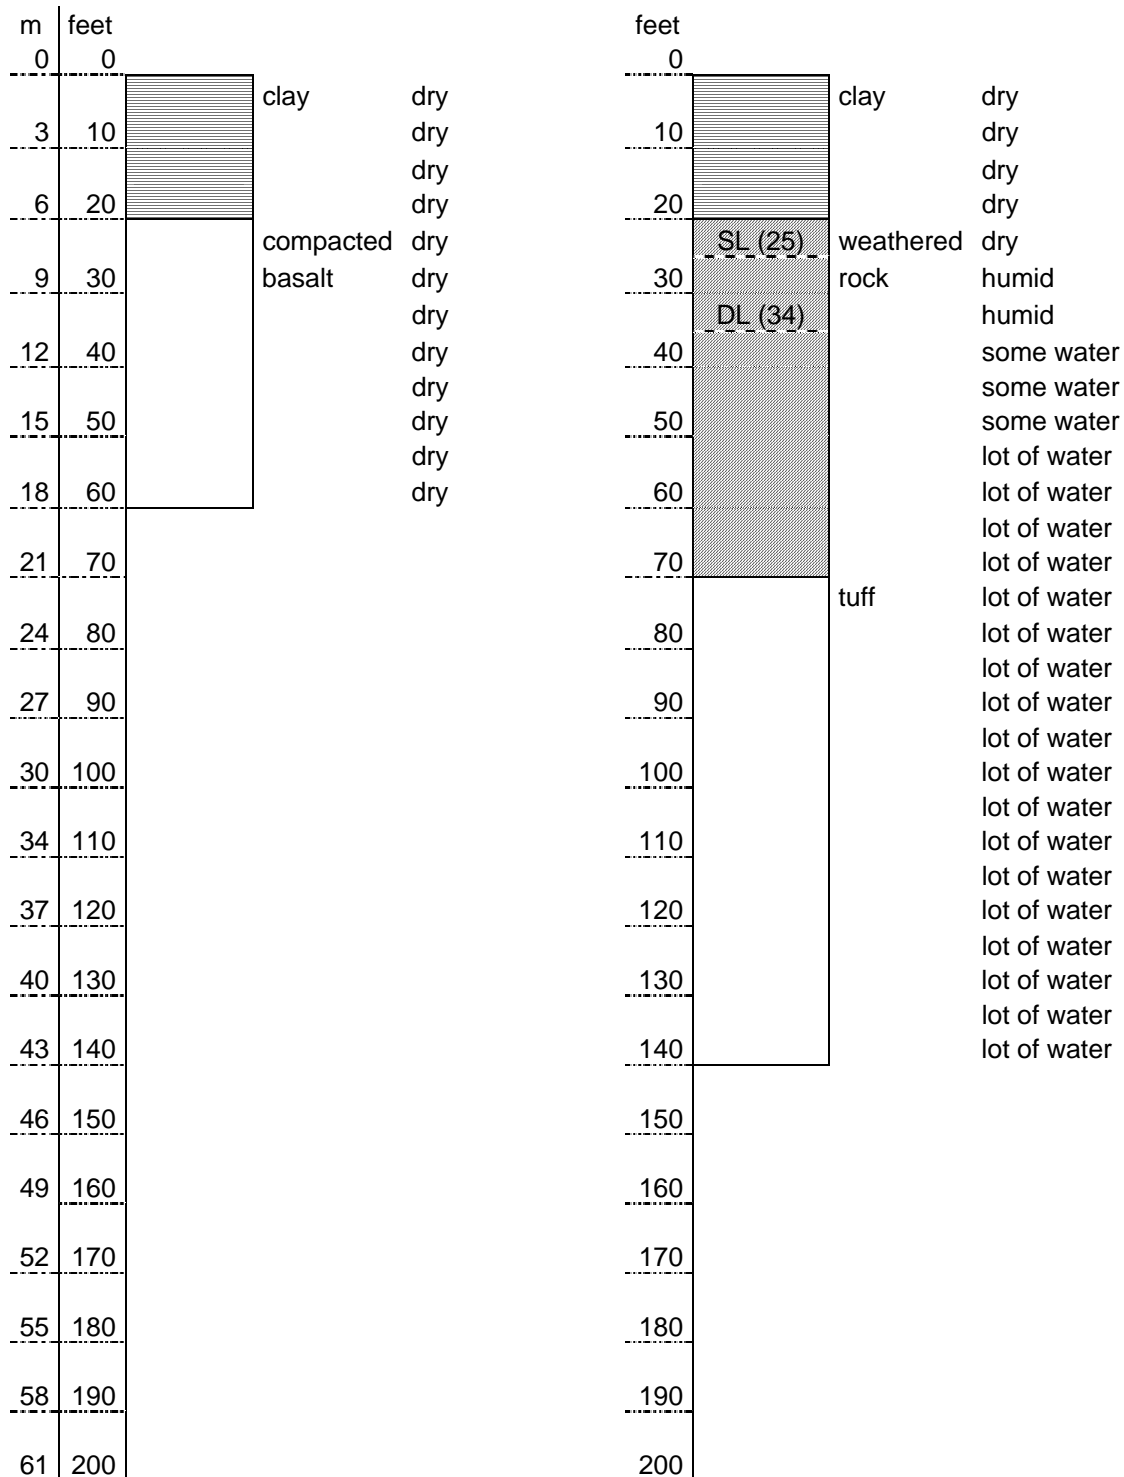
Well 23, MIDA
Carmen Esilda Ureña (1)
03-apr
no discharge, collapsed

Well 24, MIDA
Carmen Esilda Ureña (2)
03-apr
Q_{balance}=20,4 m³/h
not in use because no electricity

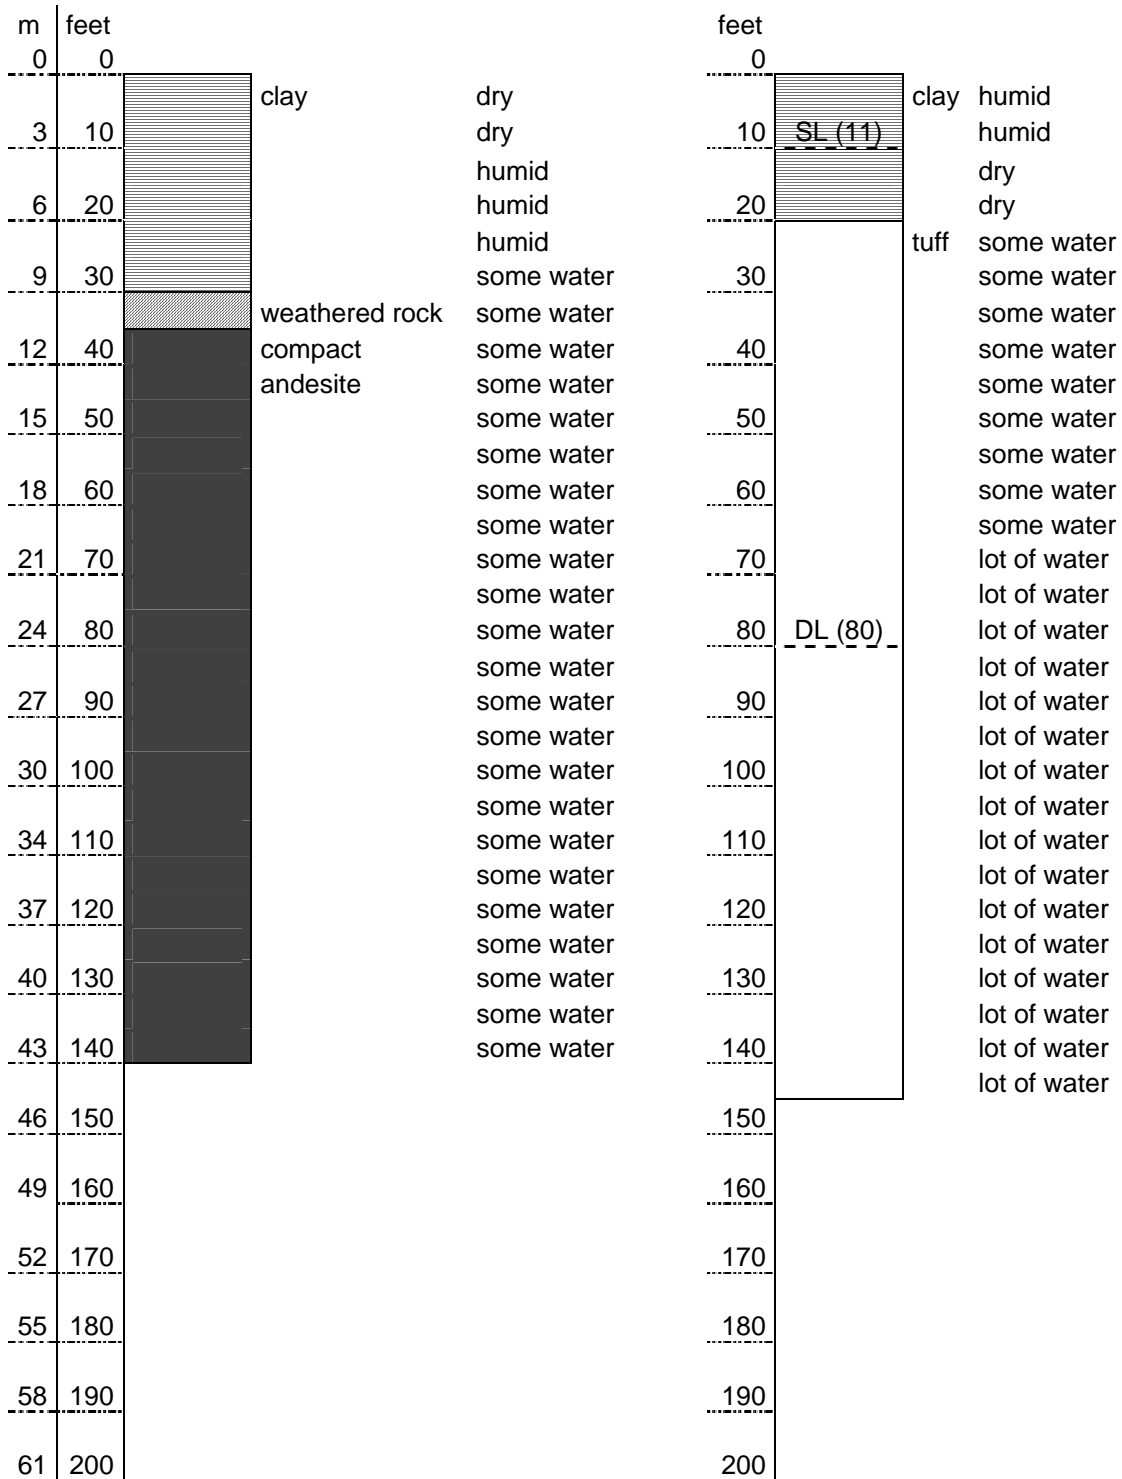
Well 25, MIDA
Heriberto Varela (1)
02-nov
not enough discharge

Well 26, MIDA
Heriberto Varela (2)
02-nov
Q_{balance}=8,6 m³/h
in use
